# ENVIRONMENTAL CONDITION – SITE CONTAMINATION STUDY

December 2021  
J174764

Fairland Group Pty Ltd

Cnr Findon & Valetta Roads,  
Kidman Park

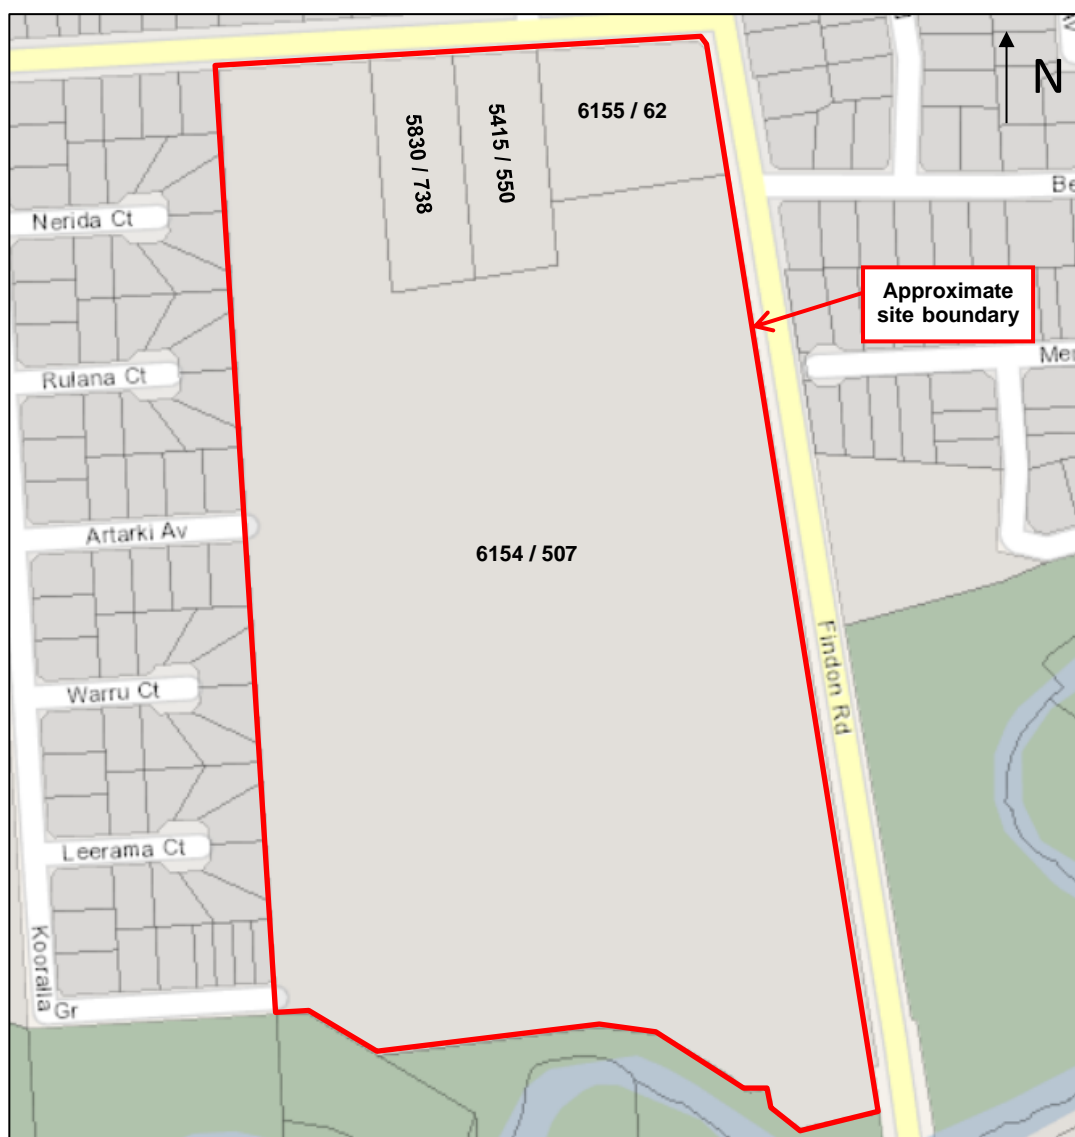
Figure 2 - Plan Showing Allotment Layout (SAPPA)

The site is described by four Certificates of Title as detailed in Table 1. A plan showing the allotment layout is presented as Figure 2. The current Certificates of Title for the Metcash site and the Property Parcel Reports from the South Australian Property Parcel Atlas (SAPPA) are presented in Appendix A.

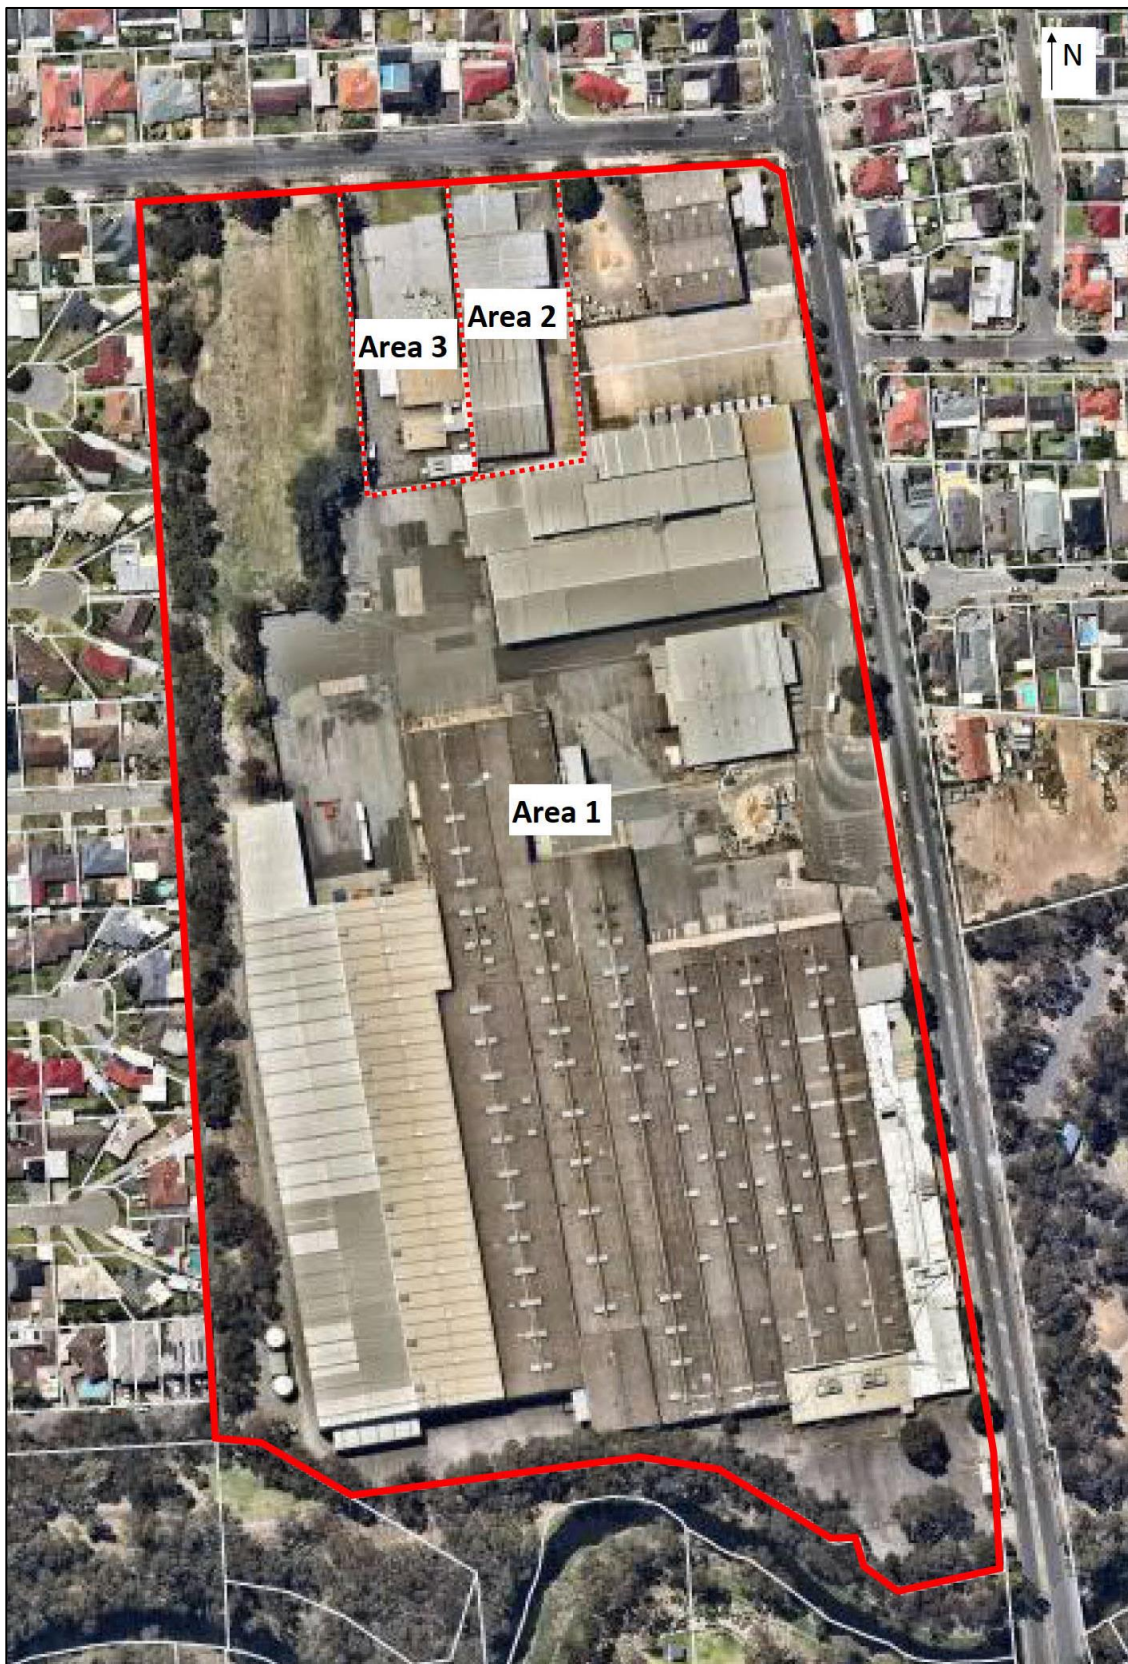
Figure 3 – Aerial image showing site areas

Additional detail regarding the current uses of the site, where available, is provided in subsequent sections of this report. A plan showing the areas above is presented as Figure 3.

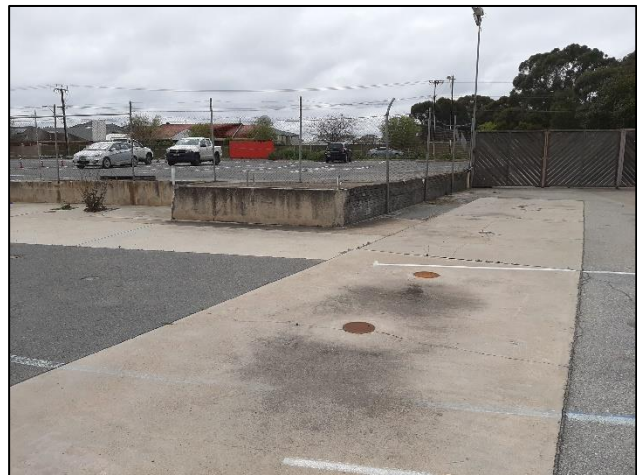
- Five underground storage tanks (USTs) containing diesel and leaded petrol and associated infrastructure. There are two areas where USTs are located. There appears to be two USTs located in the western portion of the site and at least three USTs located in the eastern portion of the site. Photographs of the two areas are presented below:

**Photographs 1 & 2 – USTs in the western (left) and eastern (right) portions of the site (24 September 2021)**

- Elevated results were also reported for hydrocarbons around the two UST areas. Some of the results at depth around the eastern USTs exceeded the health screening levels for vapour intrusion (assuming a residential land use). There were also soil impacts around the western USTs, but at the locations tested, the results did not exceed the adopted assessment criteria.
- Asbestos containing material was identified at one location under the former dry goods warehouse at a depth greater than 1.0m. This was in the form of cement sheet fragments, but there were also some loose fibre bundles identified.

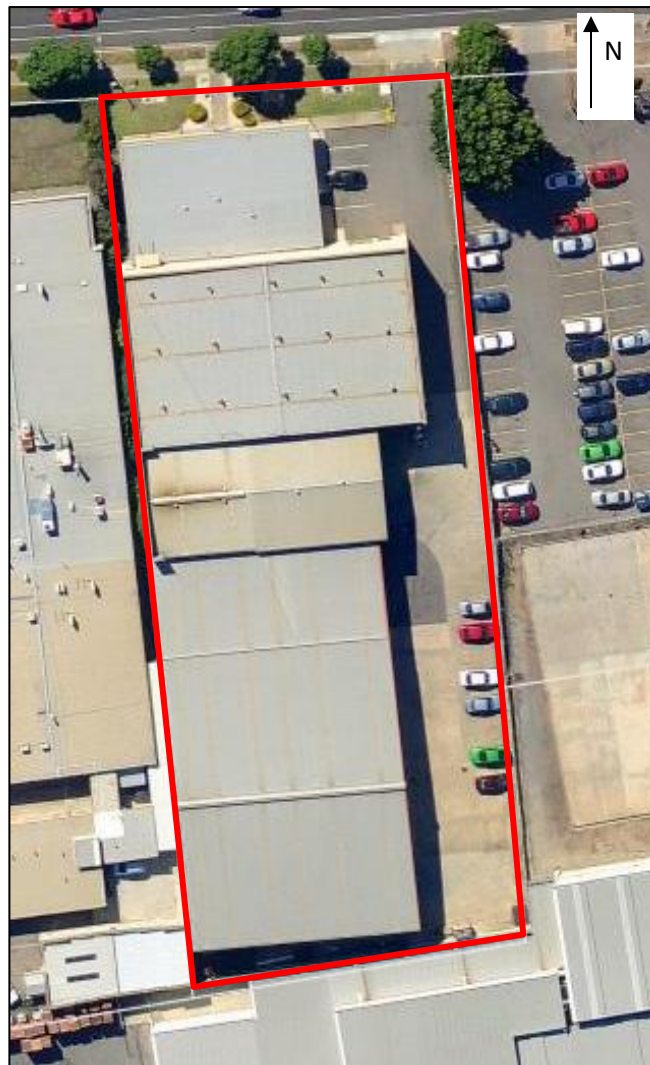
Figure 5 – Area 2 Layout

Area 2 is approximately 4,360 square metres in size and fronts Valetta Street. The site is almost entirely sealed except for a small area of garden beds adjacent the northern site boundary. Several large inter-connecting buildings cover most of the site. An aerial image showing the current site layout is presented as Figure 5 and photographs from the site boundary follow.

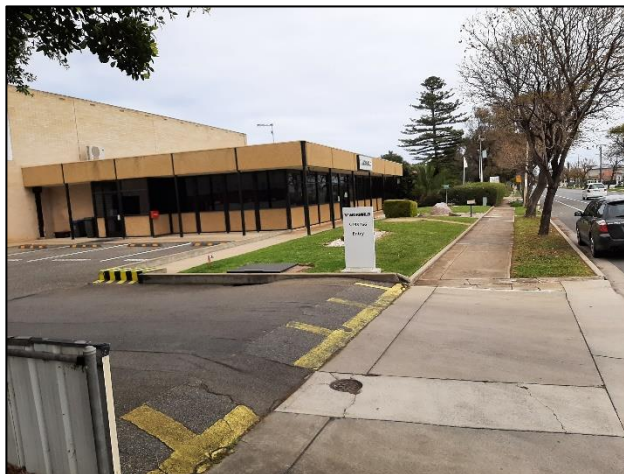
**Photograph 5 – view looking west along northern boundary of Area 2**

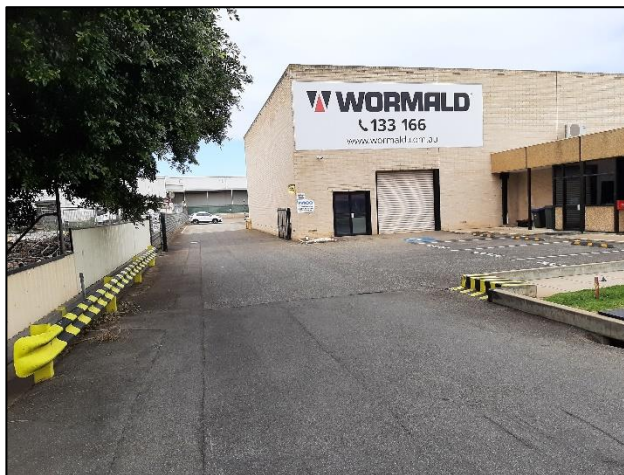
**Photograph 6 – view looking south along eastern boundary of Area 2**

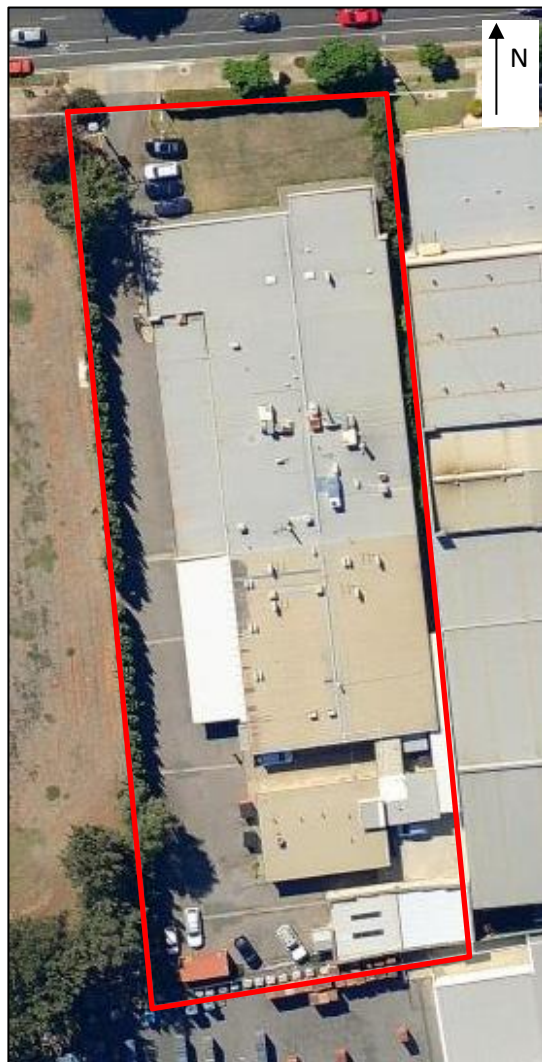
Figure 6 – Area 3 Layout

Area 3 is approximately 4,550 square metres in size and fronts Valetta Street. The site is almost entirely sealed except for a grassed area in the northern portion of the site and garden beds along the western site boundary. A large building covers most of the site, and there are several smaller structures in the southern portion of the Area. GreenCap notes that no site inspection has been completed as the site is owned by a third party. GreenCap is not aware of any proposals for redevelopment of this portion of the site. An aerial image showing the current site layout is presented as Figure 6 and photographs from the site boundary follow.

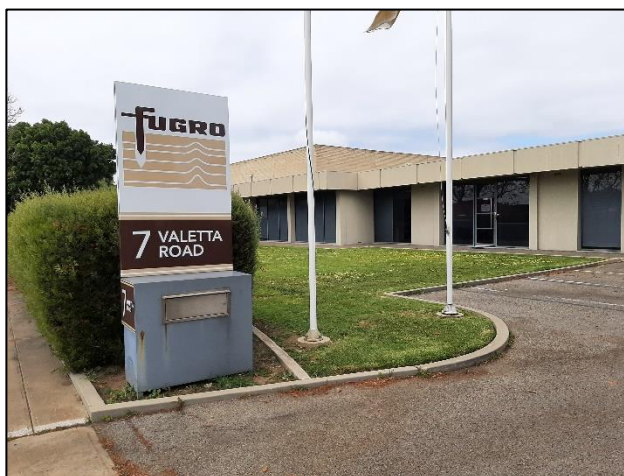
**Photograph 7 – view looking south east across the northern portion of Area 3**

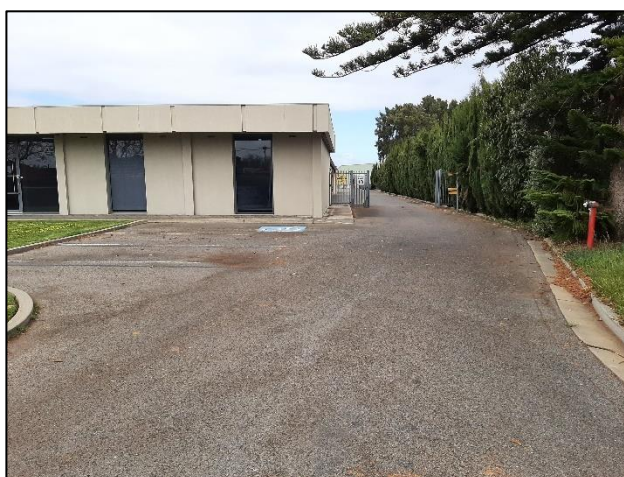
**Photograph 8 – view looking south along the western boundary of Area 3**
