Environmental Condition – Site Contamination Study

**APPENDIX C 2015 ENVIRONMENTAL SITE ASSESSMENT
REPORT**

ENVIRONMENTAL SITE ASSESSMENT

404-450 Findon Road, Kidman Park

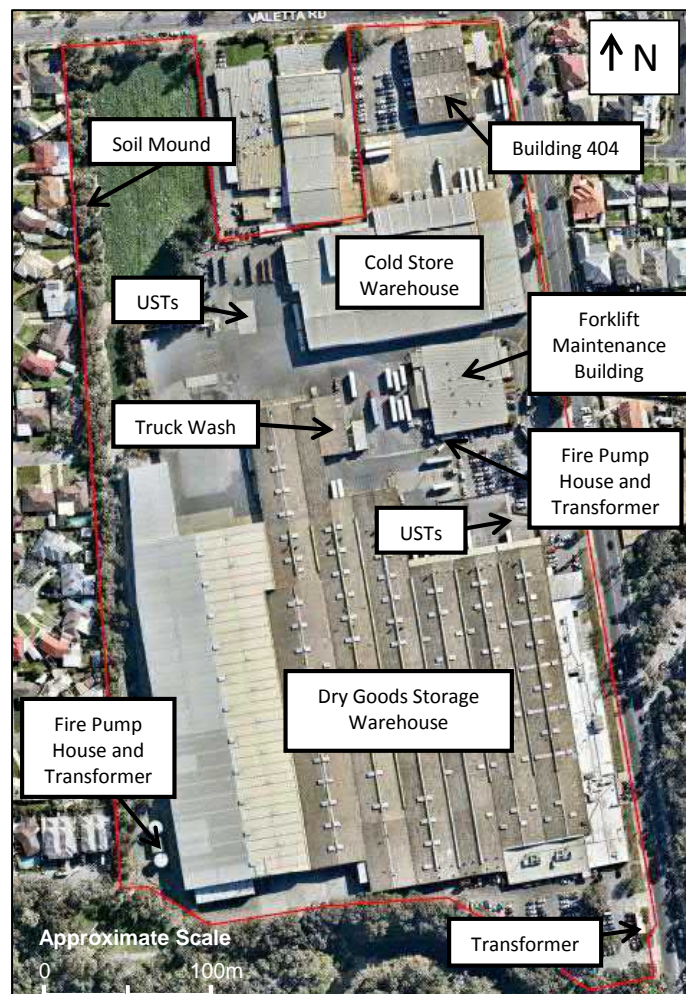
Figure 2 – Current Site Layout

The site is an irregular shaped parcel of land with a total area of approximately 11.9 hectares. The site is currently operating as a food distribution outlet (dry and frozen goods) and comprises several warehouses, offices and loading areas. The current site operations include warehousing and distribution of goods, washing of trucks and forklift maintenance.

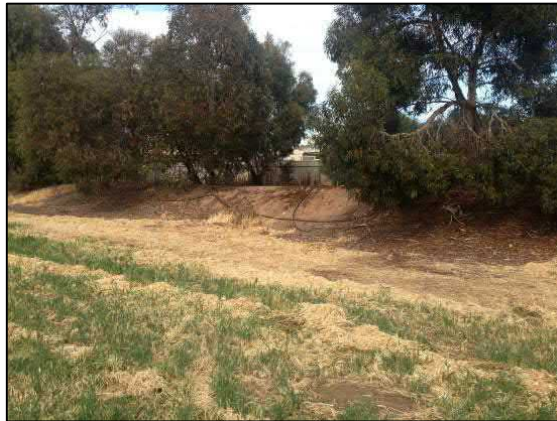
A soil mound is present along the north western boundary of the site.

Photograph 15 – View of the soil mound in the north west of the site

- A sump and an interceptor trap were noted within and adjacent to the truck washing area.
- Fill material – An elongated soil mound (approximately 100 metres long and 3 metres high) was located on the north western boundary of the site. In addition, areas of fill material were noted on the ground surface on the northern portion of the site (where exposed soil is evident). It was also noted that the land adjacent to the southern boundary of the site was at least five metres lower than the site. This was thought to likely be a result of fill being brought onto the site for site levelling and build up.

Leaf litter was present at the surface of the soil bores drilled in the soil mound located along the north western portion of the site. Fill material was encountered in the soil bores to a maximum depth of 1.2mbgl. The fill material generally comprised crushed rock mixed with silts and sands. Secondary constituents were noted within the fill material including bitumen, crushed rock, red brick, organic matter and glass fragments. Ash and cinders were noted to be present within HA3 and HA4. Underlying natural soils were encountered at all soil bore locations comprising dark brown silty clay. No odours, staining or suspected asbestos containing materials were noted during the investigation.

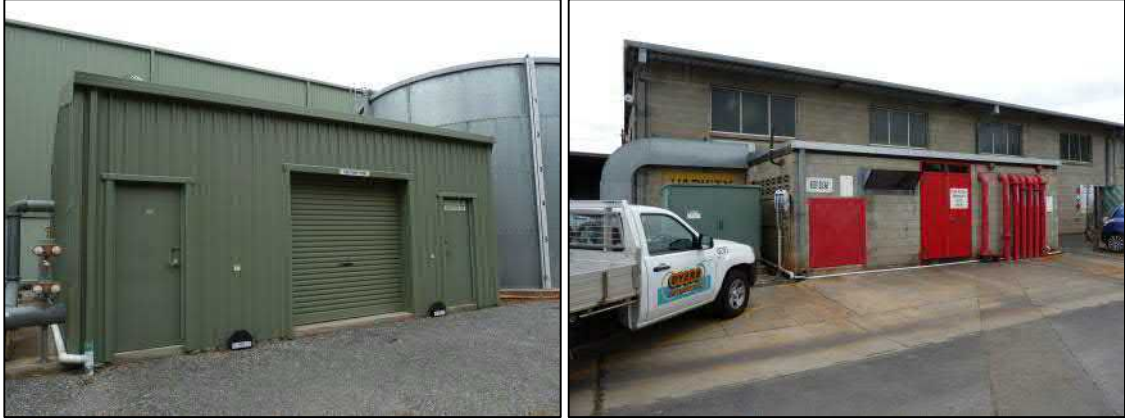
A fire pump house (containing a diesel generator and storage drum), electrical transformer and two water storage tanks are present in the south western portion of the site. A fire pump house containing a diesel generator and electrical transformer are present in the north of the site adjacent to the maintenance building. A secondary pump house is present adjacent to the main warehouse in the centre of the site.

Photograph 18 & 19 – View of the fire pump houses in the south west and north of the site

- Water tanks and Fire Pump House – A third Fire Pump House and two associated large water tanks were noted in the south western corner of the site. The Fire Pump House contained a diesel powered generator and an estimated 20 litre capacity diesel day storage drum.

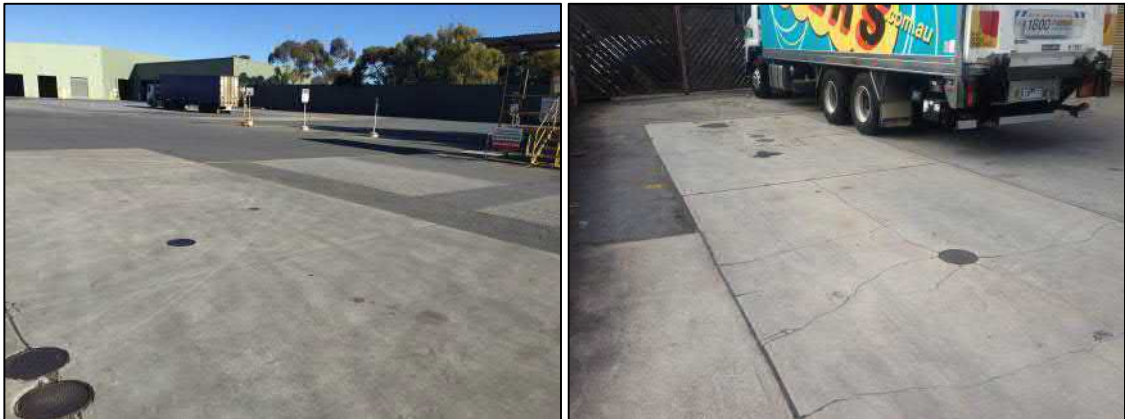
Underground storage tanks (USTs) are present in the north western and eastern portions of the site. Previous investigations undertaken in these areas have identified some fuel related impacts in soil and groundwater. Further details on the nature of the impacts along with details relating to the USTs are presented in Section 3.0.

Photograph 20 & 21 – View of the USTs in the north western and eastern portions of the site

A bitumen cover was present at soil bore locations drilled around the underground storage tanks (USTs) in the north western and eastern portions of the site, but it is noted that the tanks themselves were covered by concrete. Fill material was encountered in the soil bores to a maximum depth of 1.4mbgl, with deeper fill noted around the USTs in the northern portion of the site. The fill material generally comprised brown silty sand and grey / pale brown sand. Secondary constituents were noted within the fill material including crushed rock, red brick and bitumen fragments.

The majority of PID readings were recorded below 2 parts per million (ppm). Elevated PID readings (ranging from 15.2 to 222 ppm) were reported in TB02 and TB08 located around the USTs in the northern portion of the site between 4.7 and 6mbgl. Elevated PID readings (ranging from 4.2 to 344 ppm) were reported in TB11, TB12 and TB16 in the north eastern portion of the site between 4.0 and 7.0mbgl. All PID readings are noted on the soil bore logs presented in Appendix B.

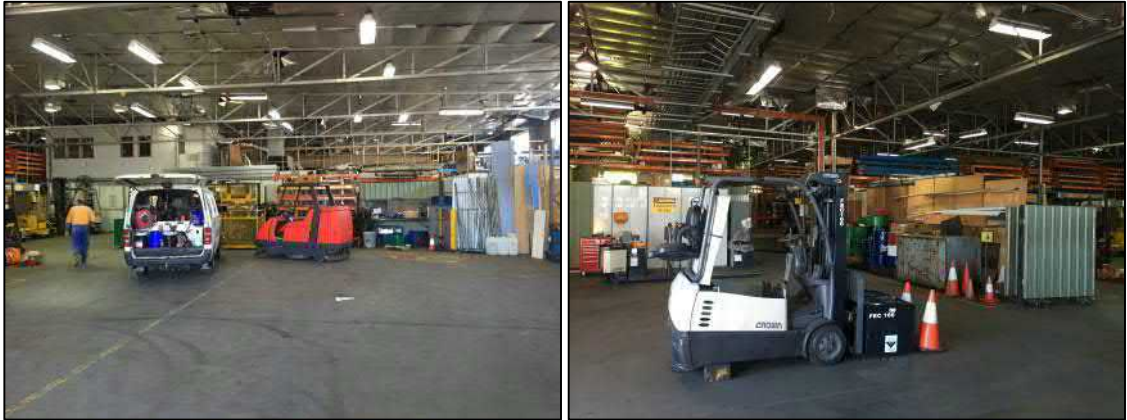
A workshop used for the maintenance of forklift trucks (and formerly trucks) is present in the northern portion of the site.

Photograph 22 & 23 – View of the forklift maintenance area in the north of the site

- Workshop – The workshop area located in the central portion of the site was utilised as an area to conduct maintenance on the on-site forklifts. A small chemical / waste oil store was noted on shelves in an unbunded area with a concrete floor.

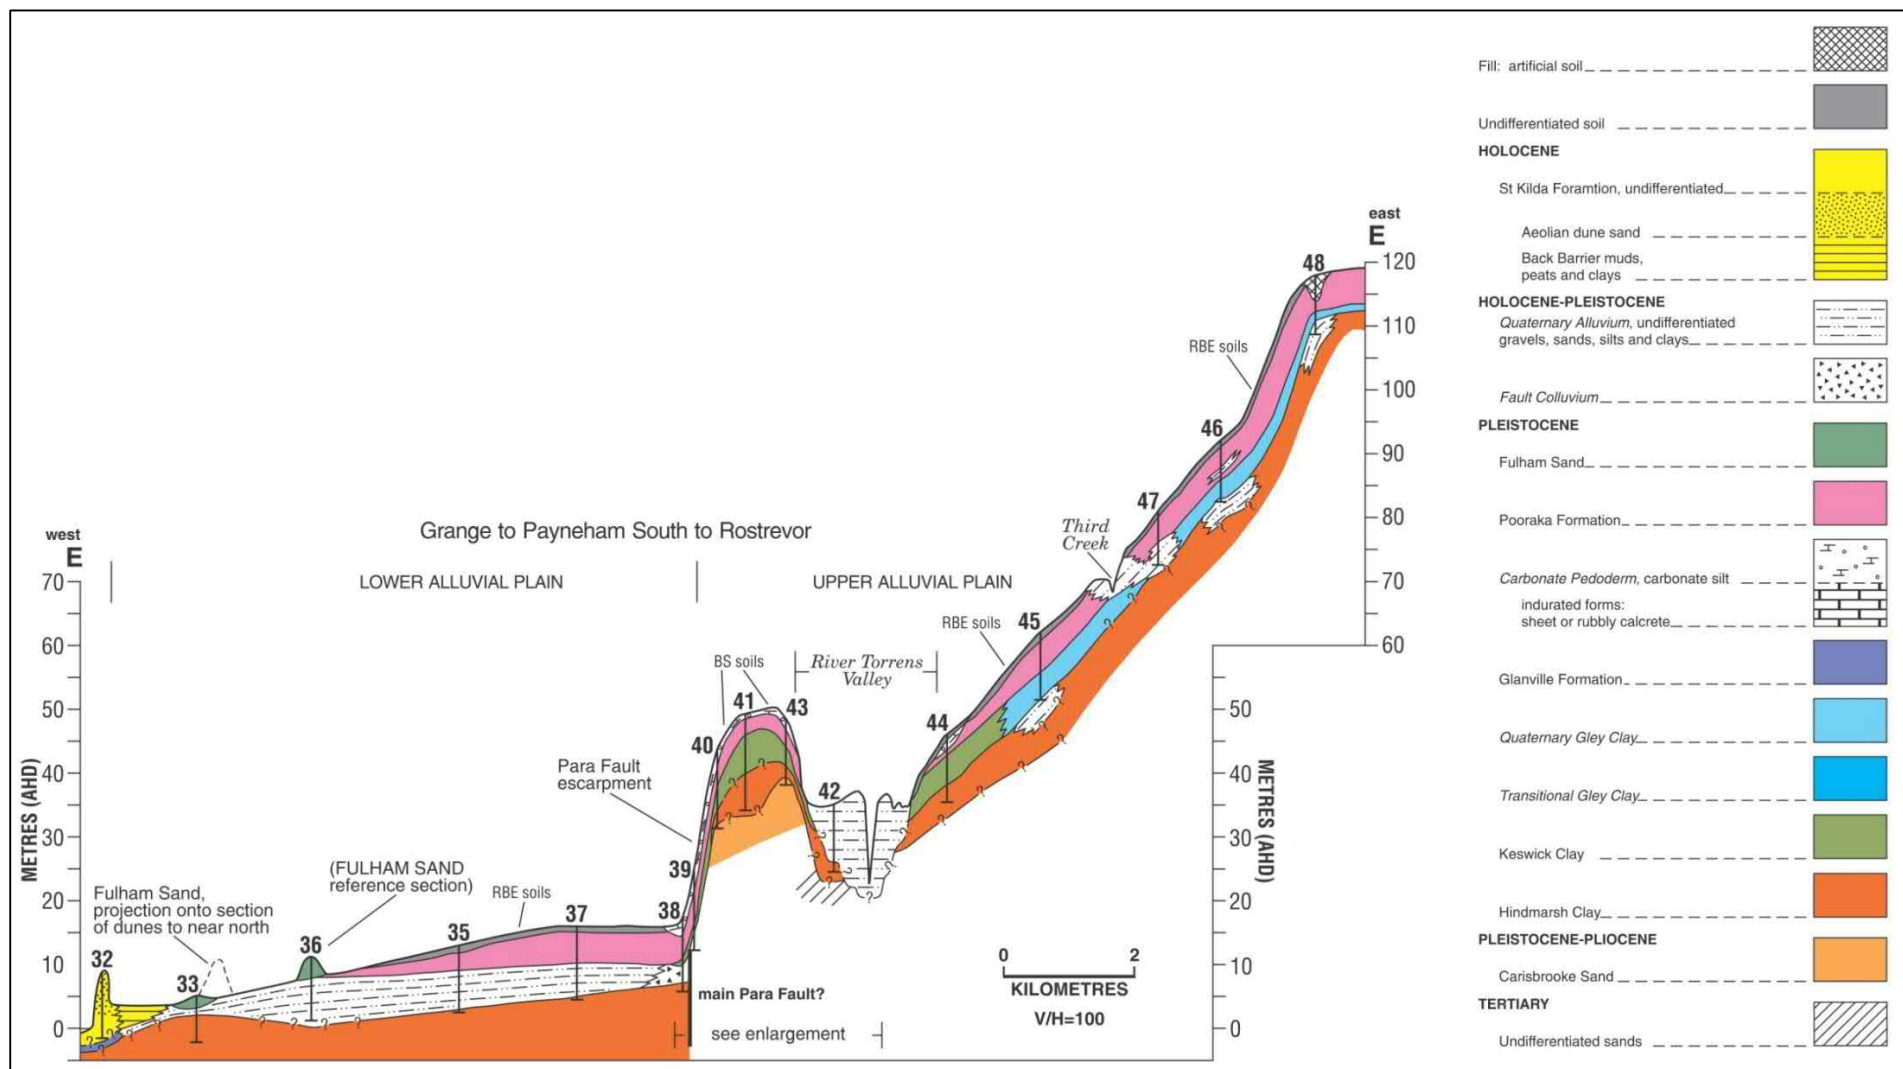
A number of cross-sections were presented in Report Book 94/9 as shown in Figures 6 and 7. Cross sections which run in the vicinity of the site (E-E and L-L) are reproduced in Figure 8 (E-E section) and Figure 9 (L-L section). Cross sections indicate that the site is likely be underlain by the following:-

- The Pooraka Formation – approximately 3 to 6 metres thick:
 - The Pooraka Formation typically consists of sandy clay and clayey to sandy silt, with interbedded clay layers, sand and occasional gravel. Layers rich in carbonate silt and segregations occur within the Pooraka Formation.
- Quaternary Alluvium – approximately 5 to 8 metres thick:
 - Quaternary Alluvium – is found throughout the Hindmarsh Clay and the Pooraka Formation. The deposits follow present and past drainage lines that emerge from the Eden–Burnside and Para Fault Escarpments. The material is predominantly sandy in texture and may also contain abundant silt, clay, gravel and pebbles.
- Hindmarsh Clay – greater than 10 metres thick:
 - Hindmarsh Clay is predominantly clay with some sand and silt content.

Figure 8 - E-E cross section and geological legend (source: DME Report Book 94/9)

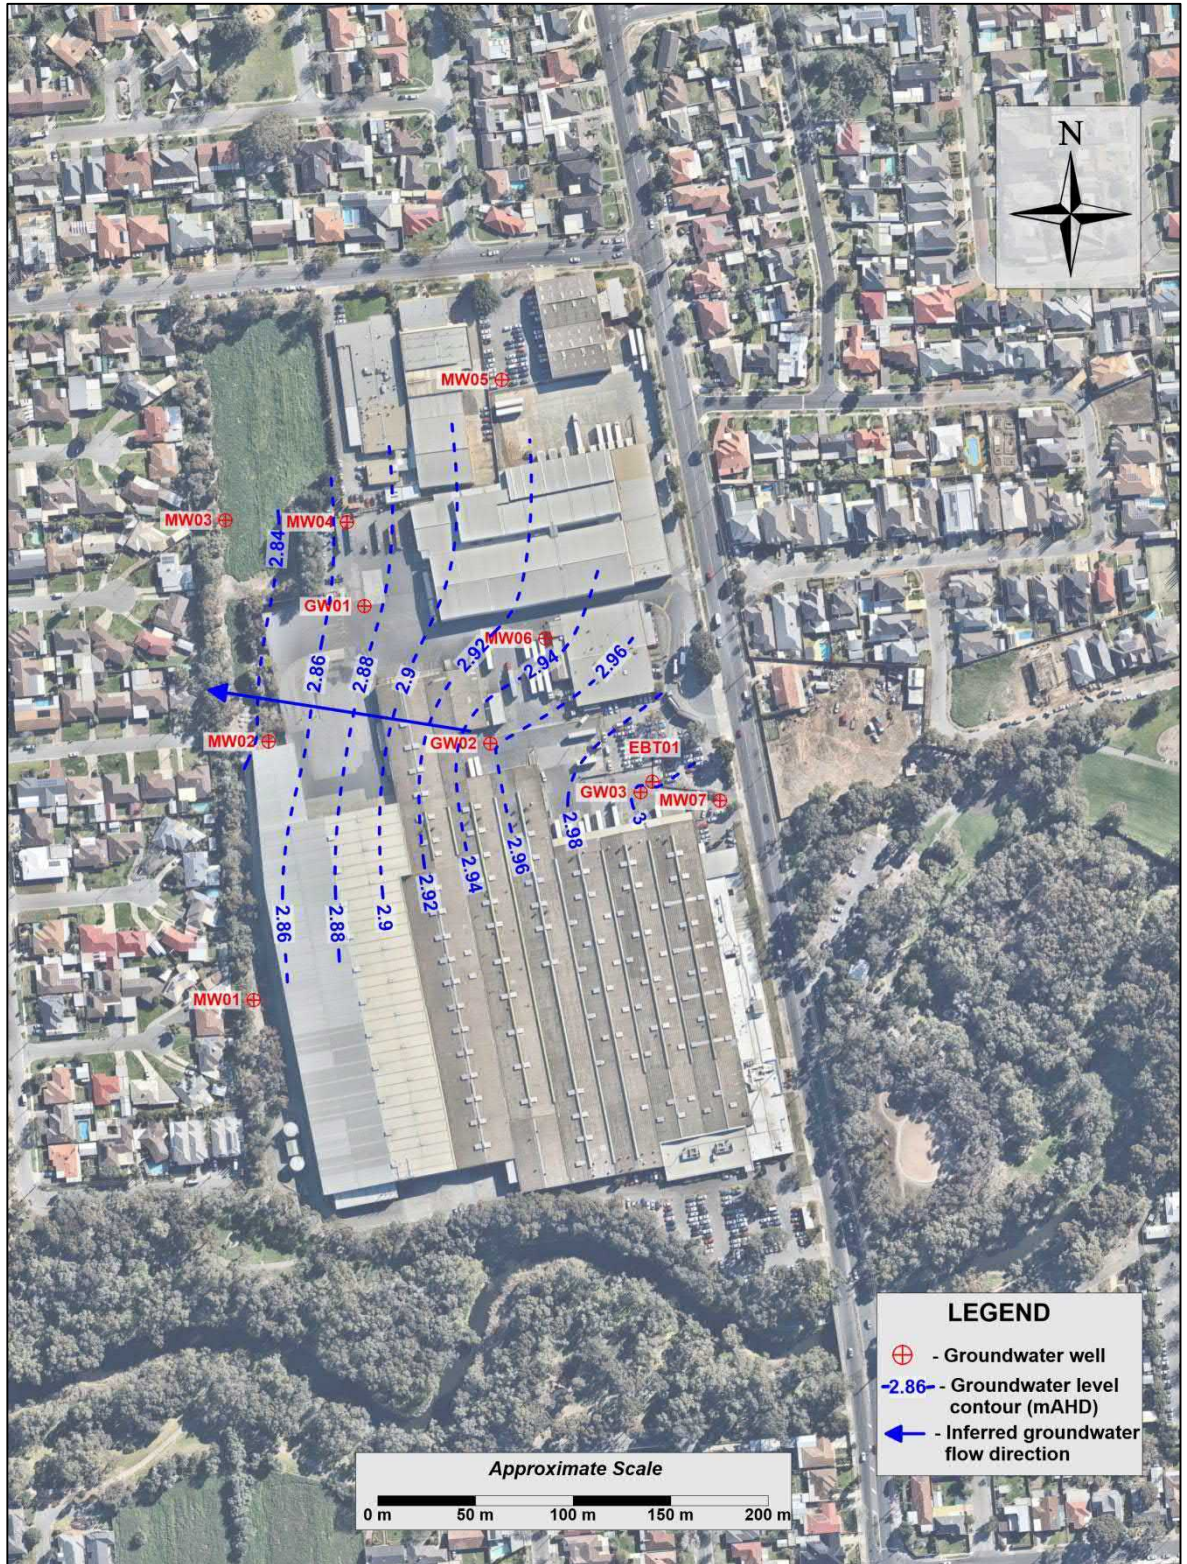
Groundwater level elevations ranged from 2.82 to 3.01m AHD. The groundwater level data has been used to construct a groundwater contour plan as shown in Figure 14. The general groundwater flow direction was assessed to be in a west to north westerly direction. The direction is consistent with the expected regional flow direction (refer Section 9.1.2).

Averaged hydraulic gradient for the Q1 aquifer at the site calculated using the October 2015 contours is approximately 0.0008 m/m.

Figure 14 – Groundwater level Contours (October 2015)
