ENVIRONMENTAL SITE ASSESSMENT (PHASE 1)

SITE HISTORY

**344-354 FINDON ROAD
KIDMAN PARK
SOUTH AUSTRALIA**

Date: January 2011
Reference No: 5112
Report Version: 5112/02

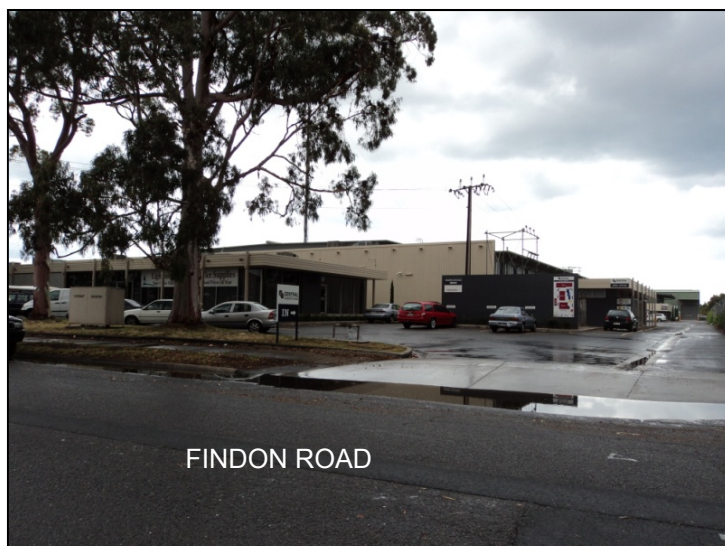
View facing west at front of site

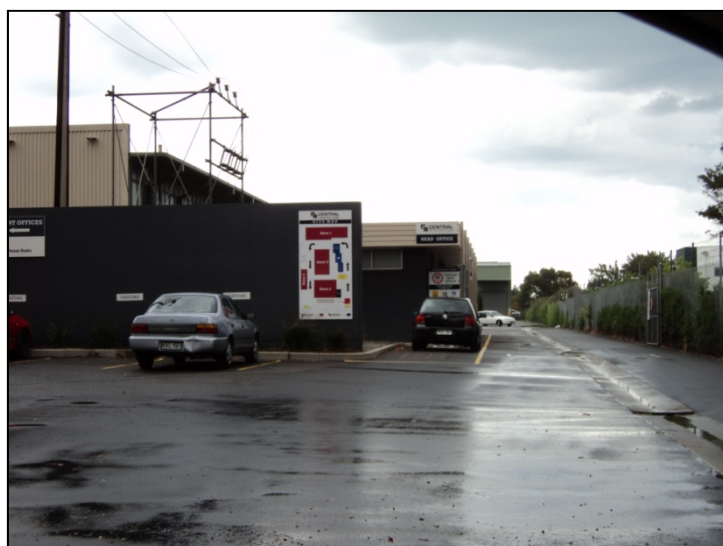
View facing west across the northern boundary of site

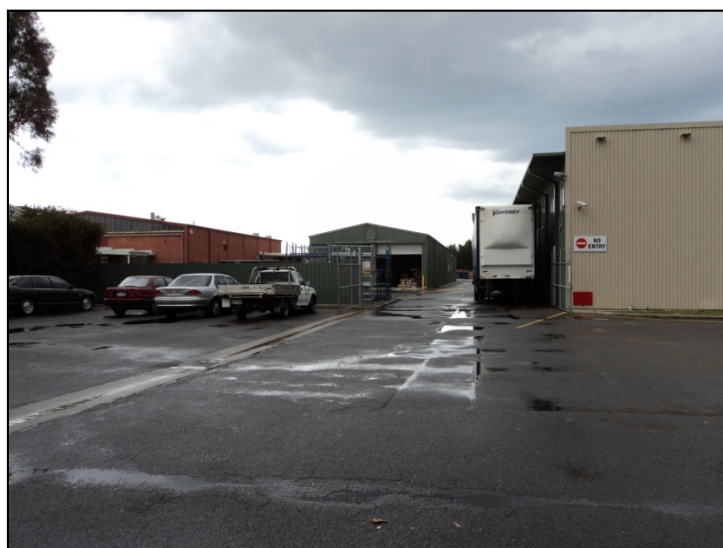
View facing west across the southern boundary of site

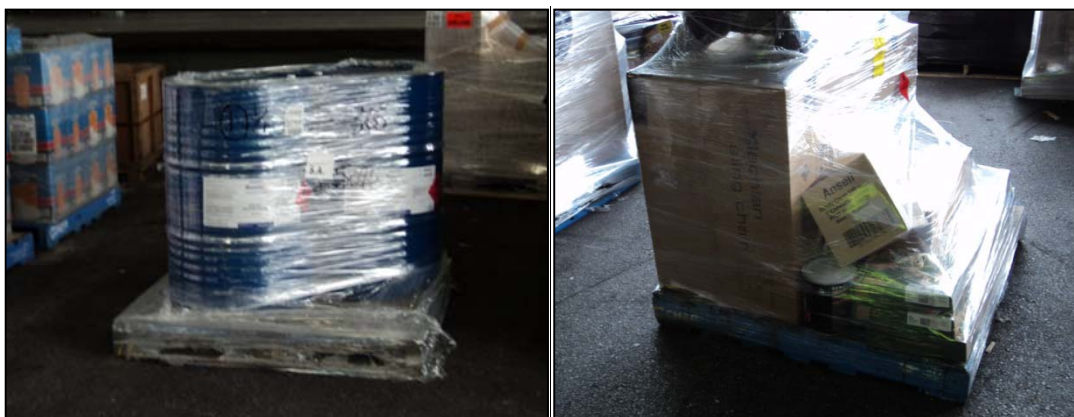
Various goods are brought to site daily as part of the operations of the freighting company that currently occupies the site. The items of interest noted during the inspection were adhesives, paints and tyres. These goods were packaged on pallets and wrapped in plastic. The goods were handled in areas that were completely covered by either bitumen or concrete that appeared to be in good condition. No obvious drainage was noted in these areas.

View of Freighting Goods (includes drums & boxes containing adhesive)

| Potential Contamination Sources | | Contaminants of Potential Concern | Likelihood of Occurrence | Likely Significance |
|---|--|---|---|---|
| On-Site | Freighting operations - storage of adhesives and paints | TPH, BTEX, PAH's and metals | Unlikely | Low significance |

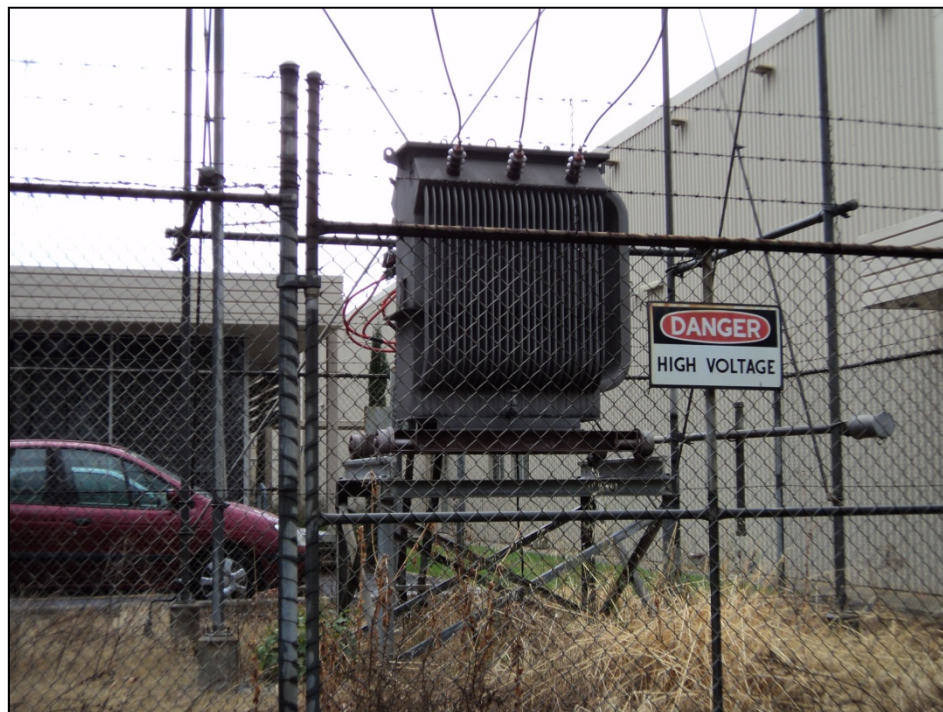
An electrical transformer was located in the north eastern portion of the site. The transformer is raised off the surface on a steel frame. A photograph is presented below.

View facing south at electrical transformer

| Potential Contamination Sources | | Contaminants of Potential Concern | Likelihood of Occurrence | Likely Significance |
|---|--|---|---|---|
| | Leaks from electrical transformer | PCB's | Unlikely | Low significance |
